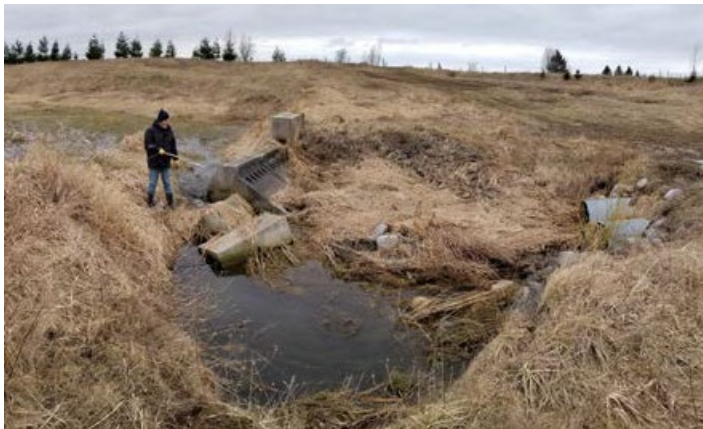
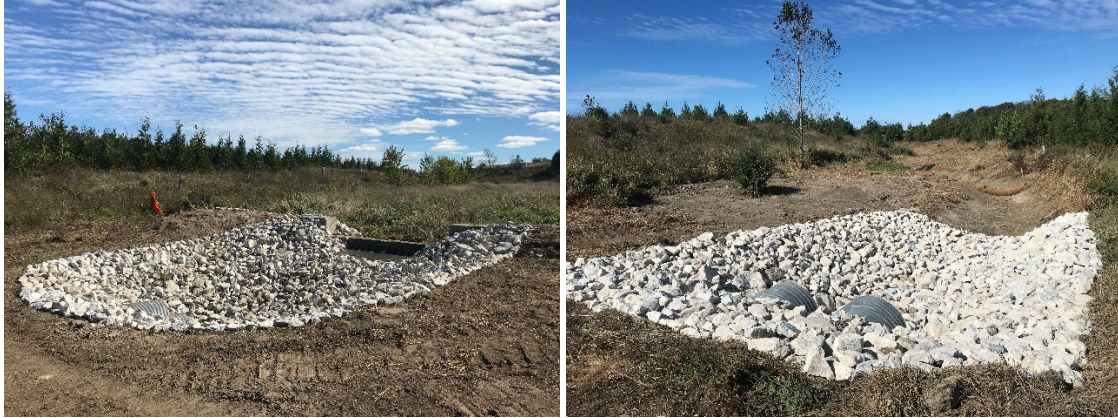
Step two, an old water and sediment control basin (WASCoB) was repaired. The cement blocks of the WASCoB had continually shifted out of place over the years from the force of the water moving through the ditch. Our contractor put each block back in place and utilized rip rap to reinforce the structure as well as prevent erosion from occurring on the banks.

Below you will see a 'before' picture of the WASCoB (picture credit to SVCA), followed by two 'after' shots of the work completed. In the 'after' photos (left) you will see the cement blocks of the WASCoB on the right side of the rip rap blanketed area, to the left are two culverts which run under a crossing. The rip rap continues on the other side of the WASCoB (to the right of the cement blocks) as well as on the other side of the crossing to stabilize the banks.

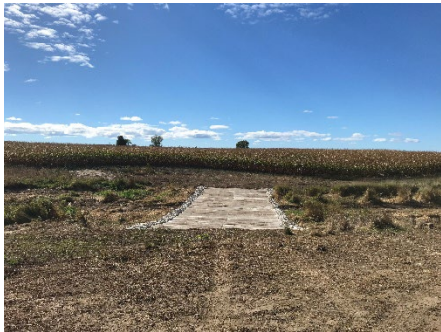
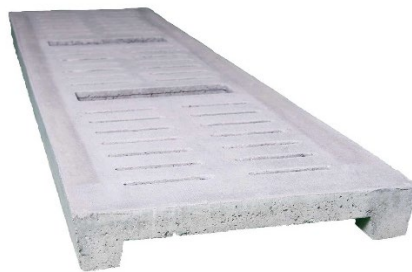
Step 3, an equipment crossing was constructed to protect the structure of the ditch as it is a pathway between cropping fields. The crossing is made of concrete hog slats, which have a bench design and surface cut outs to allow water to flow and fall through to collect in the ditch. There is rip rap on either side of the crossing, which is to prevent any build up of soil against the hog slats potentially clogging up the openings, while also allowing water to slowly flow through and overtop of the rip rap. The hog slats follow the contour of the ditch, so there is minimal danger of water overflowing outside of the ditch. Below is a photo of the constructed crossing (left) and an individual hog slat (right) to see and understand its design.
